IMPROVEMENT LOCATION REPORT

that on July 28, 2008, I made an inspection of the premises situated at Brie's Way in Taos, Taos County, NM briefly described as (Lot 36 of the Dos Arroyos Subdivision).
(Address, if Applicable)

EXHIBIT "A"

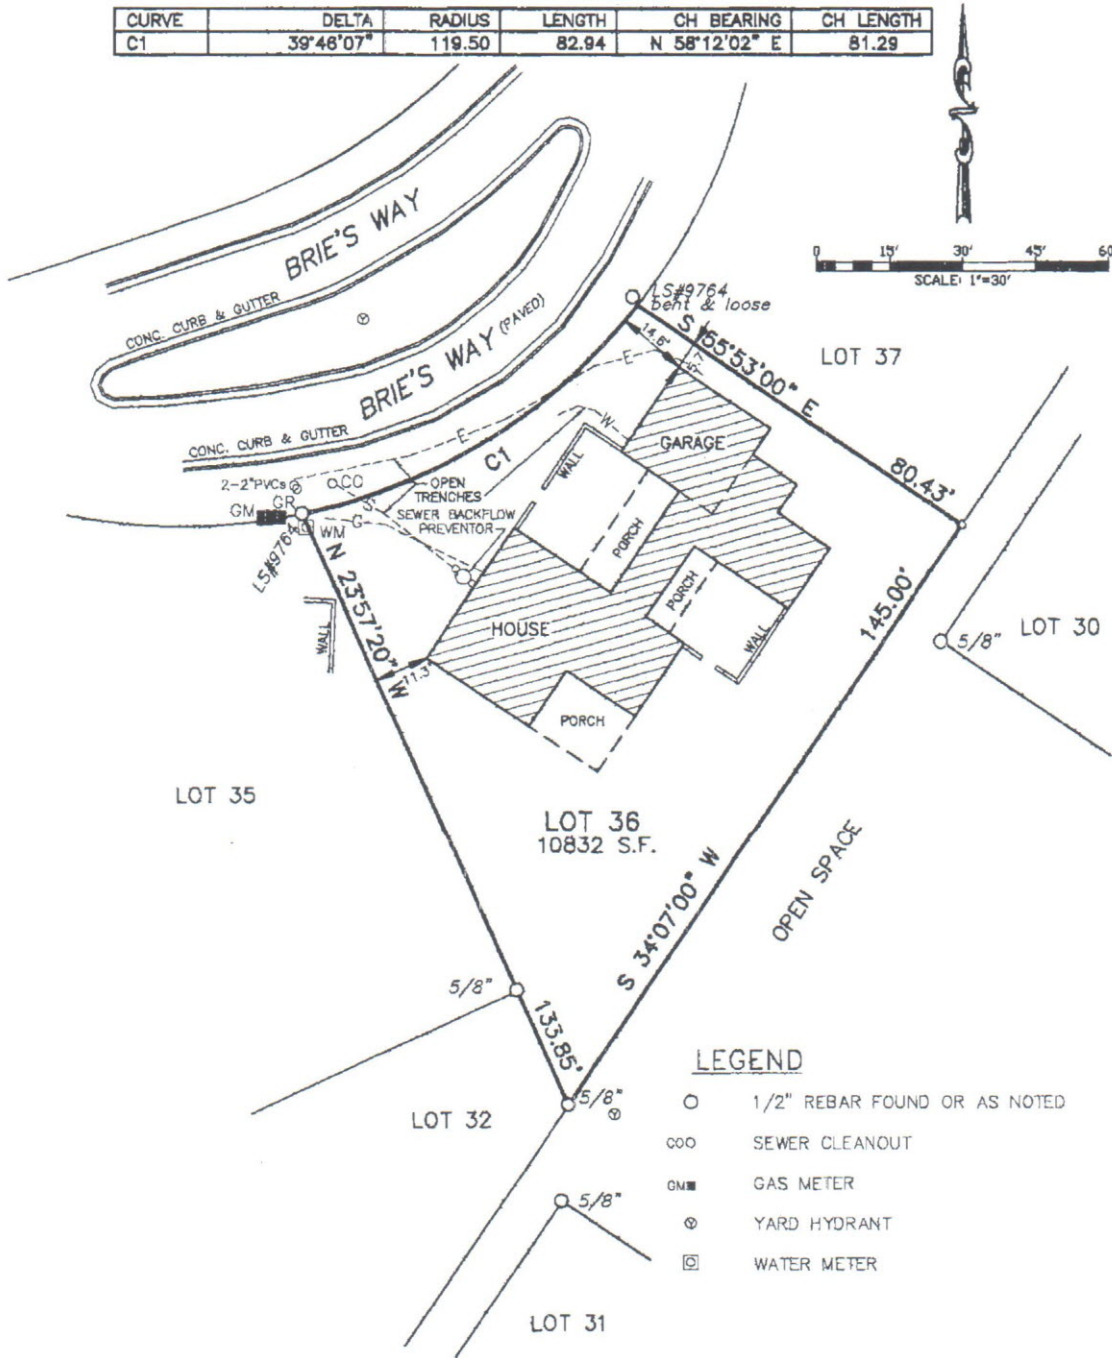
Shown on Exhibit "A"

Yes: Shown on Exhibit "A"
