## Environmental and Air Quality Systems:

- a. Solar Thermal System
- b. ERV
- c. Mud-filled Walls
- d. Radon Mitigation
- e. Pumice Wicking Bed
- f. 2.82 KW Solar Photovoltaic System

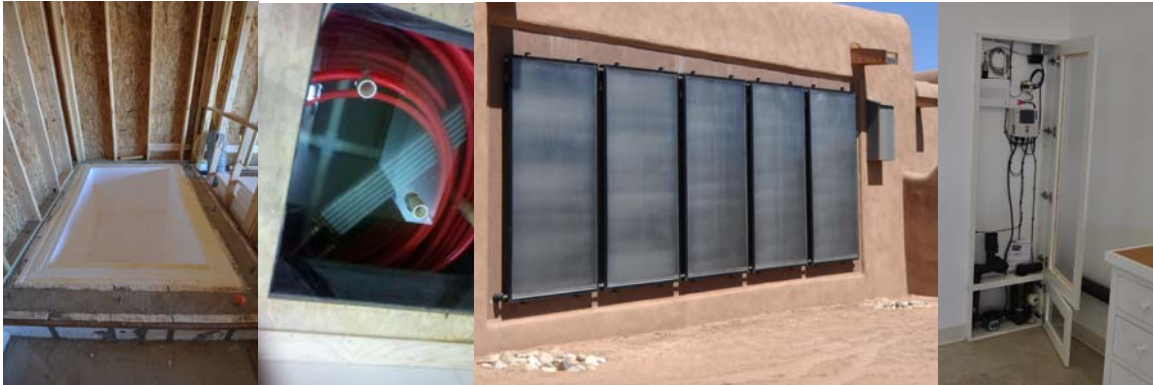
**This House has a 5 Panel Drainback solar system with 650 Gal superinsulated solar water storage tank designed to provide the vast majority of DHW and Whole House and Garage Floor Radiant Heat derived from the Sun's Energy. The performance of this system is set up to be monitored over the internet.**

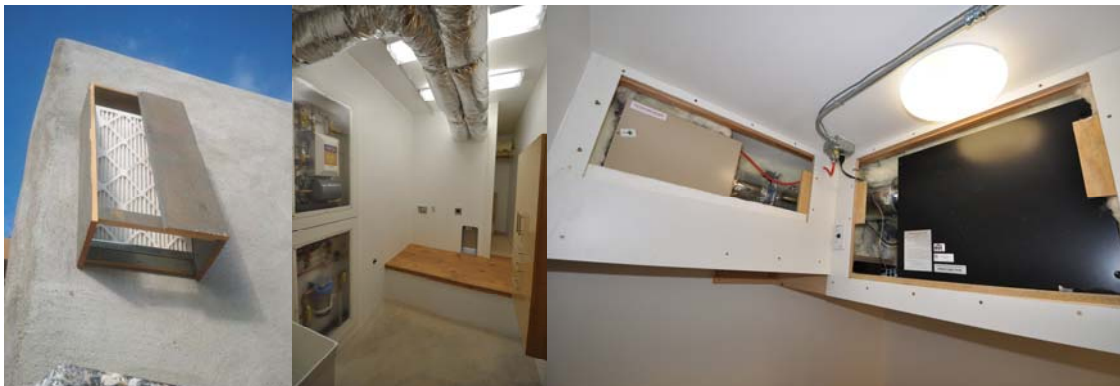
**This House has a ERV whole house ventilation system which precisely exchanges inside air with fresh outside air while exchanging the heat and humidity between the warm outgoing air and cold incoming air. Thus the house has a continuous supply of clean, filtered air providing a more allergy free, healthy indoor climate.**

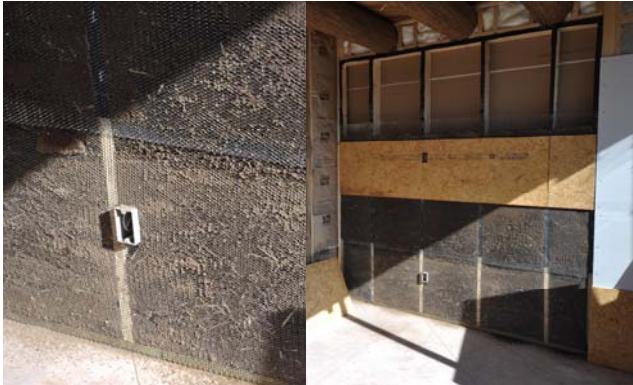
**This House has, along with the exposed concrete slabs, over 50' of interior 2x6 frame walls filled with local mud to give thermal mass and has mud plaster to help house absorb and release humidity resulting in a more stable and thus more comfortable environment. The process of hydration also releases negative ions which are reported to have positive health effects on people.**

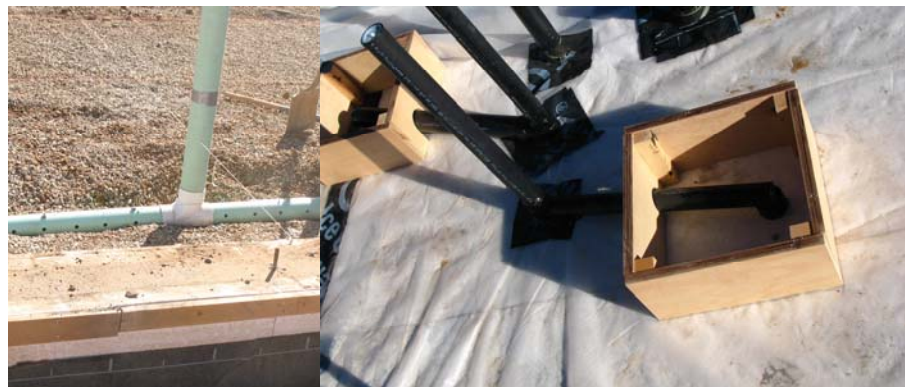
**This House has a radon mitigation system consisting of a vented sub-slab gravel bed and carefully sealed plastic barrier under the concrete slab.**

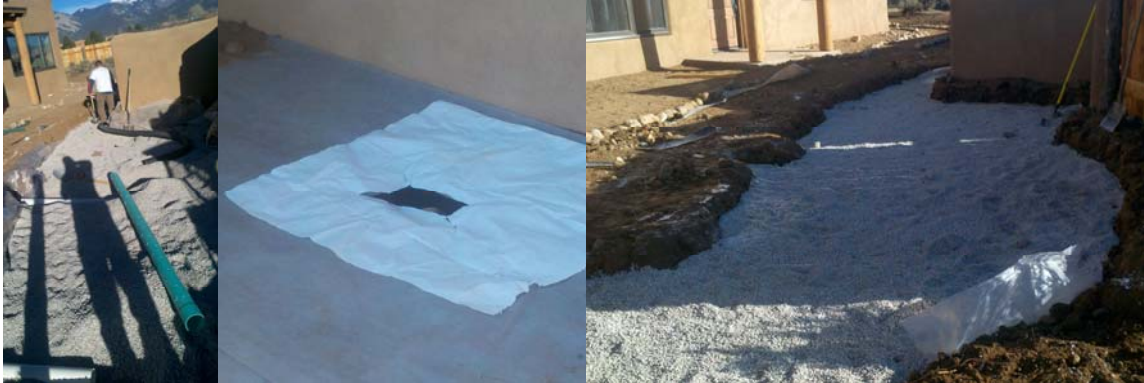
**This House's South facing canals collecting over 60% of rainwater runoff have rainwater catch basins diverting rainwater into a pumice wicking bed with 10 cu yd of pumice buried under a potential garden bed. Water not collected in this bed is channeled so it can be directed to future plantings. Additional Rainwater on the North side of the house is channeled through landscaping for future planting beds.**

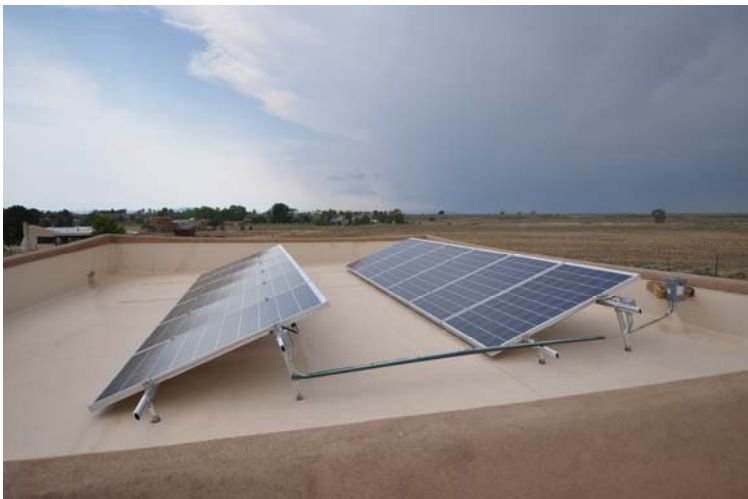
**This house has a 2.82 KW photovoltaic system which is tied to the electrical grid so that electricity generated but not used during the day is credited back through the Kit Carson Electric grid. The system is sized as to provide the majority of the house's electrical requirement. The performance of this system and each panel is set up to be monitored over the internet.**
